Nashville, TN  
March 26-28, 2006

**AIR PLENUM (DUCT SEALING) REHABILITATION AT FORD'S ROUGE VISITOR CENTER  
By CIPP methods described in ASTM F 1216 & ASTM F 1743**

Fred Tingberg Jr,

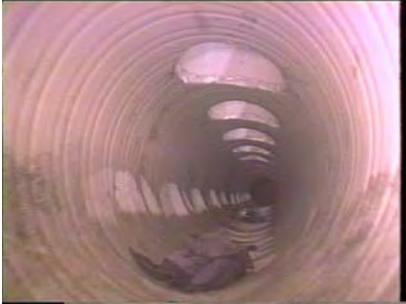
This paper addresses the rehabilitation of four (4) 20" diameter air plenum lines (Figure #1) constructed beneath the Ford (BP-432) Visitor Center Theatre in Dearborn Michigan. Prior to rehabilitation the spiral wound PVC air plenum duct material was allowing ground water to pass into the system (Figure #6), which then created the potential for mildew and mold propagation. The system defect was identified by Walbridge Aldinger, the General Contractor and Q/C Engineers at Ford's Heritage Sustainability Project 7-7130. Unfortunately with the opening date deadline looming; seats, carpeting, and other major decorative appointments (Figure #3) had been or were in the process of being installed along side this integral air system which was part of the theatre experience itself. The challenge became to identify a non destructive, trenchless means of repairing the leaks to the system in the available tight quarters of access which were available, without tolerating any demolition of the theatre complex, seating, stage or other constructed effects.

Figure #1 Pre Video of Air plenum cross run

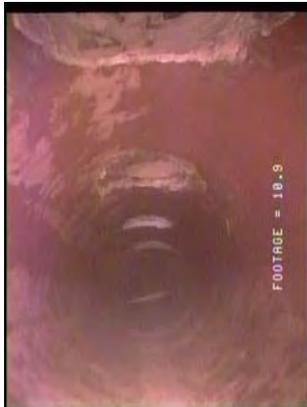
Figure #2 Post Video of Air Plenum cross run

Installation was performed by methods described in ASTM F 1216 and ASTM F 1743. A glass reinforced Novapipe polyester tube was selected which demonstrated superior invertability and dimensional control. Specifically, the delivery and return line primary runs were direct inverted, while the cross runs were installed using pull and invert technology. After lateral reinstatement, trowel able epoxy was hand applied at all liner outlets and junctions.

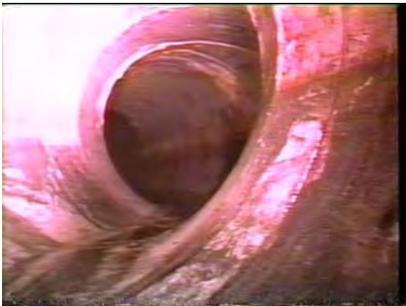
There were several system bends (Figures #4 & #5) which needed to be negotiated, while primary accesses for the main runs were through supply and return ducts at the front of the theatre. The bends were as severe as 60 degrees; however, several of the bends were simultaneous therefore challenging the CIP inversion process resulting in some fining. As a general rule, bends in the same direction may or may not cause a fin to propagate; however, directional changes are more likely to produce this anomaly. In any event the resultant fins were judged not to be performance inhibiting.

Figure #4 Pre Video of direction change

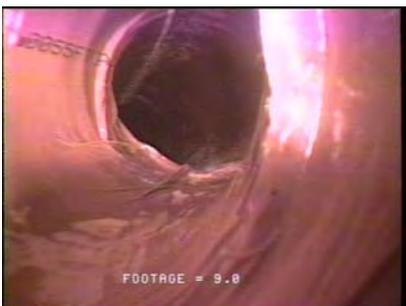
Figure #5 Post Video of direction change

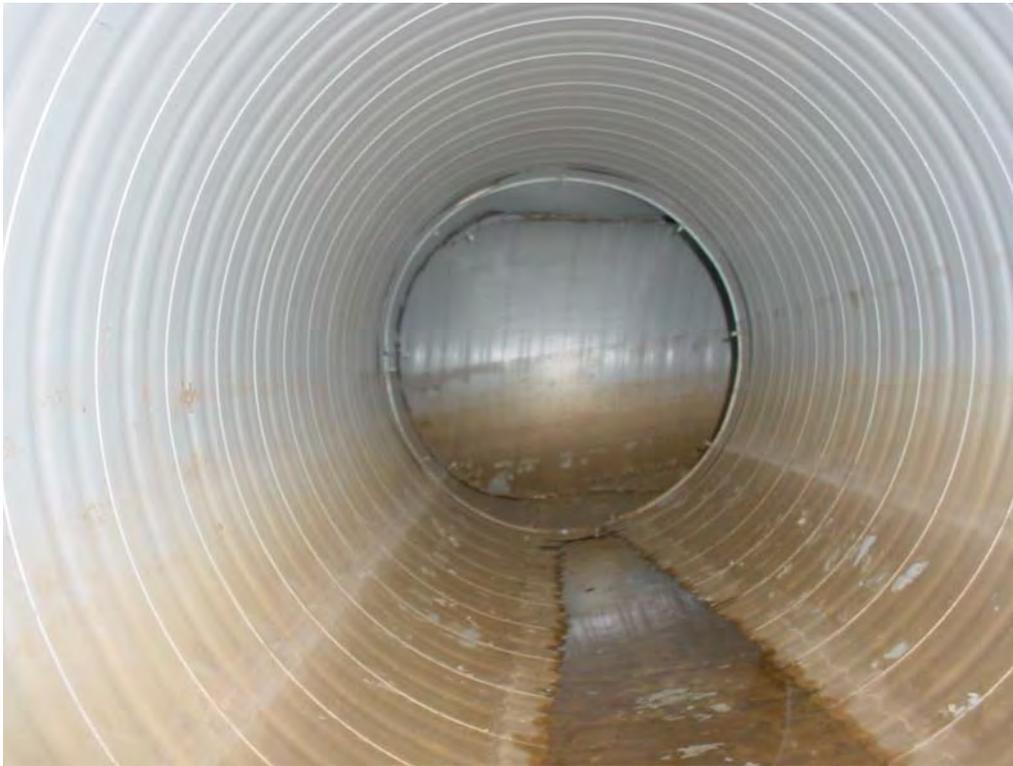
Figure #6 Pre Video of plenum junction

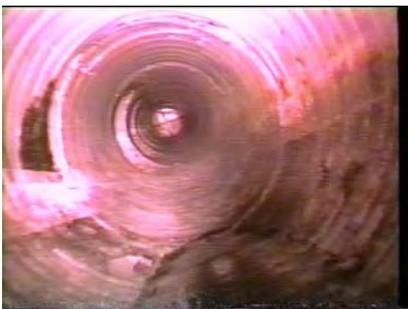
Figure #10 Internal mildew manifestation

Cleaning included a mildew retardant rinse followed by foam swabbing. Televising was by both push cam, as well as, robotic methods so that all rehabilitation limits could be documented.
