► **CARBON FIBER REHABILITATION — 48” PCCP WATER MAIN**

Carbon Fiber Rehabilitation of 48” PCCP Water Main

Miami, FL

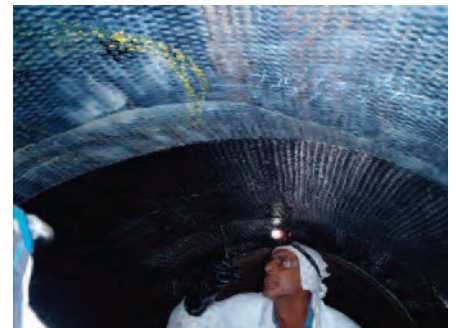
Carbon Fiber Rehabilitation

Lanzo Trenchless Technologies used a carbon fiber mesh and application process where two different meshes were applied. Lanzo Trenchless Technologies performed the work within a major roadway with multiple crews on a 24 hour-a-day basis until the job was completed. Access was maintained and the impact to traffic was minimal.
