► CARBON FIBER REHABILITATION — 54" PCCP WATER MAIN

Carbon Fiber Rehabilitation of 54" Water Main

Miami, FL

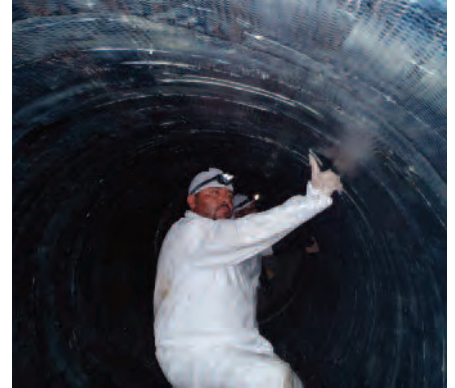
Carbon Fiber Rehabilitation

Lanzo Trenchless Technologies used a carbon fiber mesh and specialized application process where two different meshes were applied to the piping. The work was extensive and had to be conducted throughout the day and the evening hours. Lanzo was sensitive to the community needs and communicated regularly with community leaders throughout the process. There was not a single complaint during the water main repair. In addition, access to the highway was maintained and the impact to the traffic during the work process was minimal.
