## FOCUS: SEWER

# LIGHTING THE WAY

A proactive approach to infrastructure renewal in Dover, Del., includes a lining project on 3,345 feet of pipe under a main thoroughfare

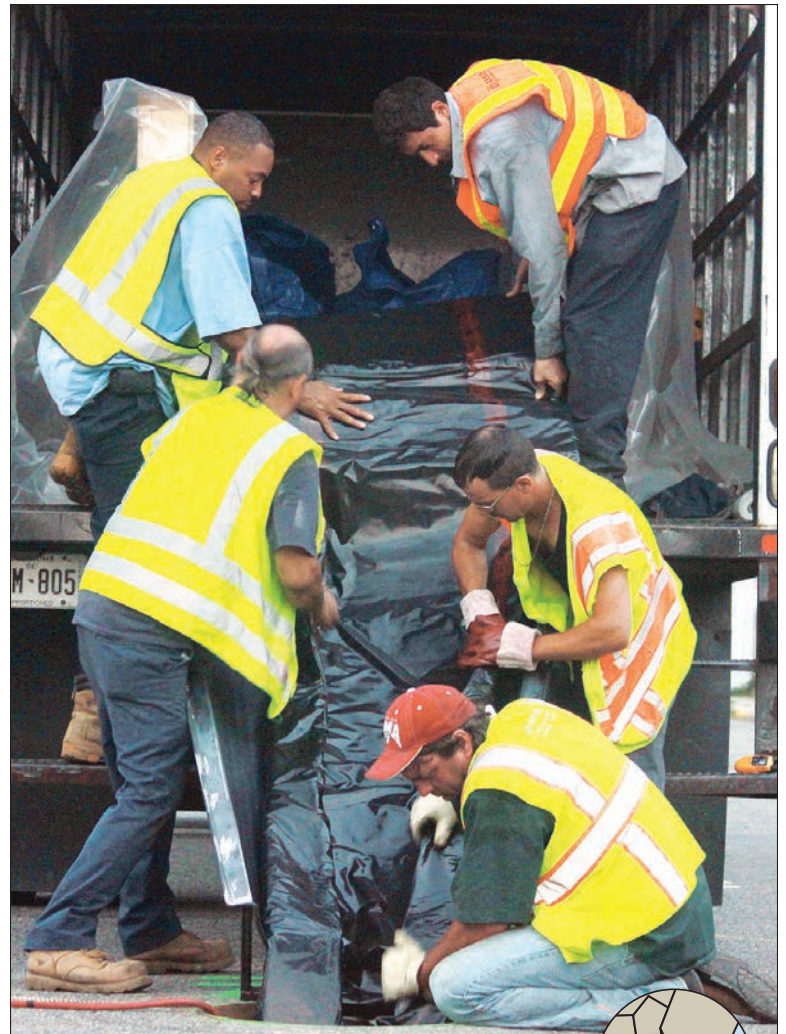
**The liner from Pacific Multilining with the black cover cut to expose the liner. Once the cover is removed, sunlight or any other UV light source starts the curing process.**

The UV-cured liner has greater tolerance for temperatures, although it’s still better to keep it cool, and also out of direct sunlight, which of course includes UV rays. Says Loewen: “If the liner sees sunlight, it’s cooked.”

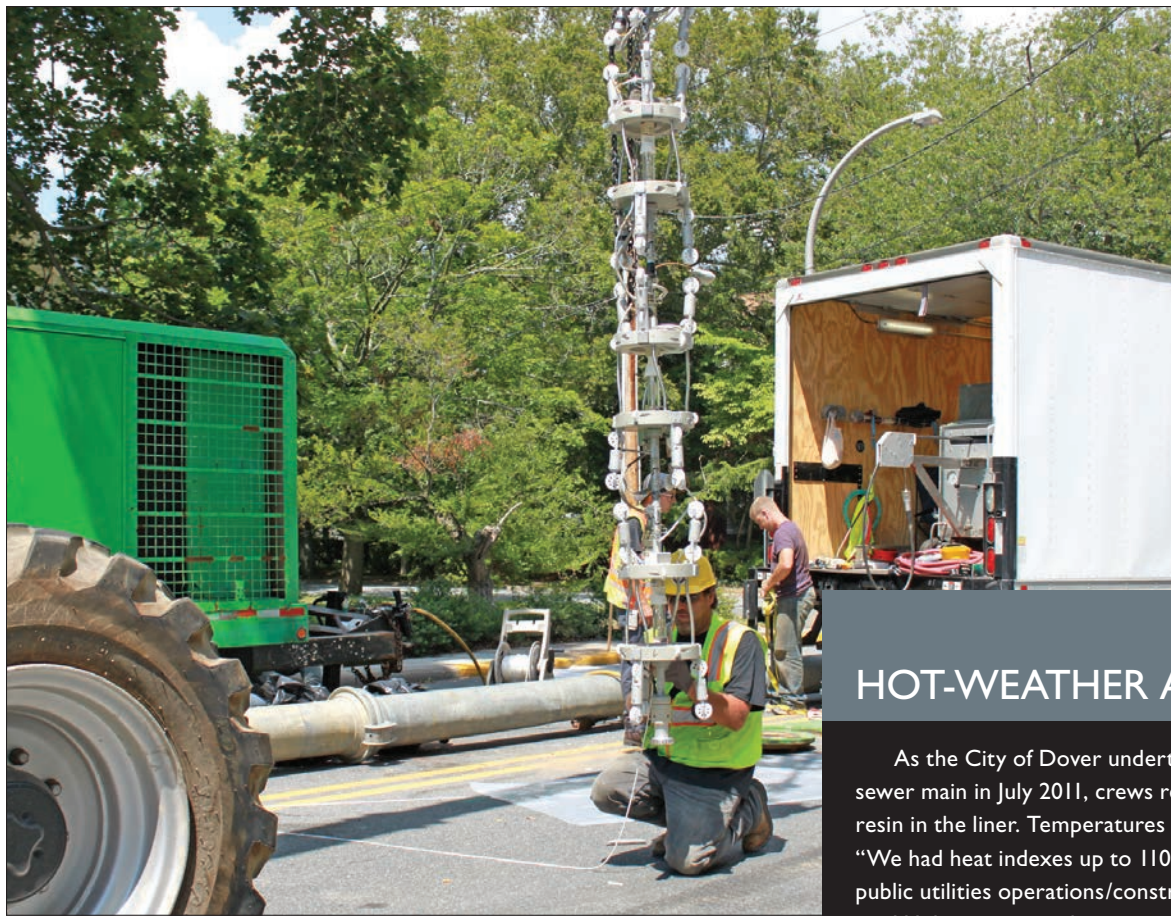
**Project superintendent Steve Carbeck checks out the light train to make sure all the parts are ready for another curing session.**

The UV light instrument sent through to cure the resin has a built-in camera on the front end — a big advantage because it allows crews to check the inside of the liner before curing it and remedy any flaws they may find.

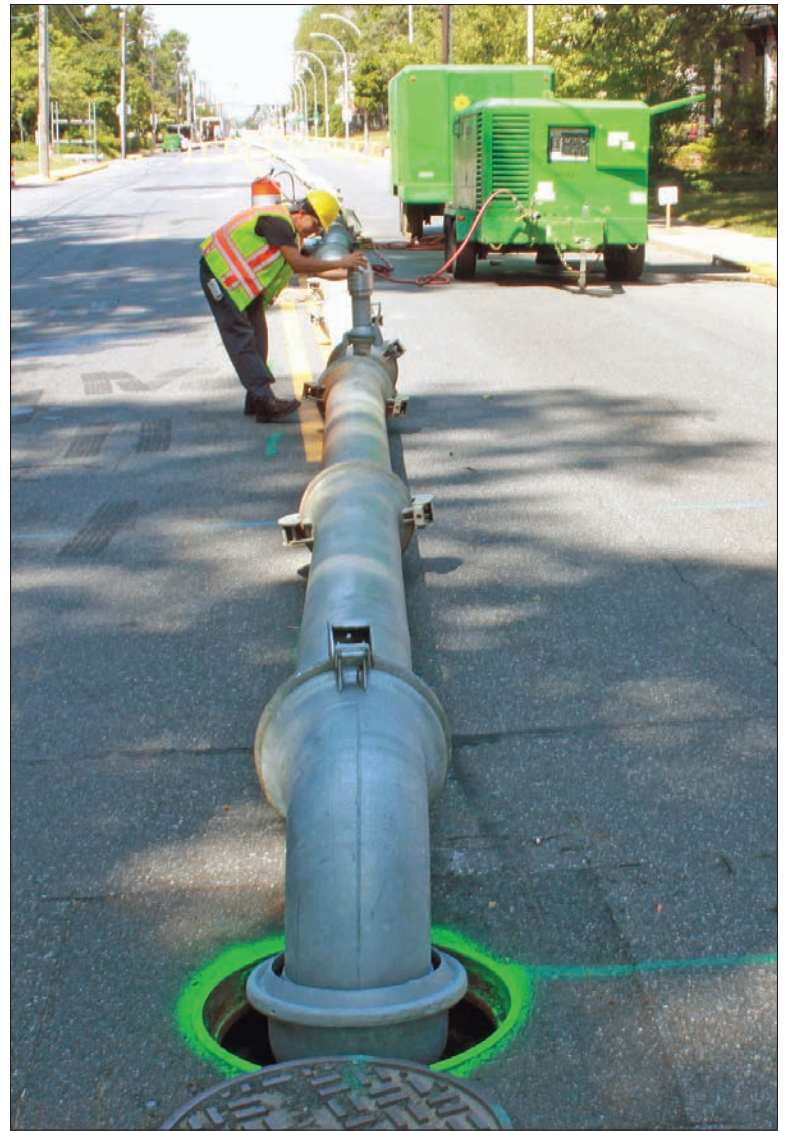
**At the end of the mile-long bypass system, a crew member checks the pressure and releases a small amount of air so that the bypass system flows with ease.**

interceptor that at the same time receives flow from the local flow basin. The pump station had ample power to drive flow through the bypass, a 12-inch pipeline that ran along the top of the street, for the first half of the project, says Tingberg. When the bypass was set up for the second half, additional pumps were used. At two cross streets that had to remain open during the work, ramps were constructed to carry traffic right over the bypass pipeline.
