FOCUS: SEWER

LIGHTING THE WAY

A proactive approach to infrastructure renewal in Dover, Del., includes a lining project on 3,345 feet of pipe under a main thoroughfare

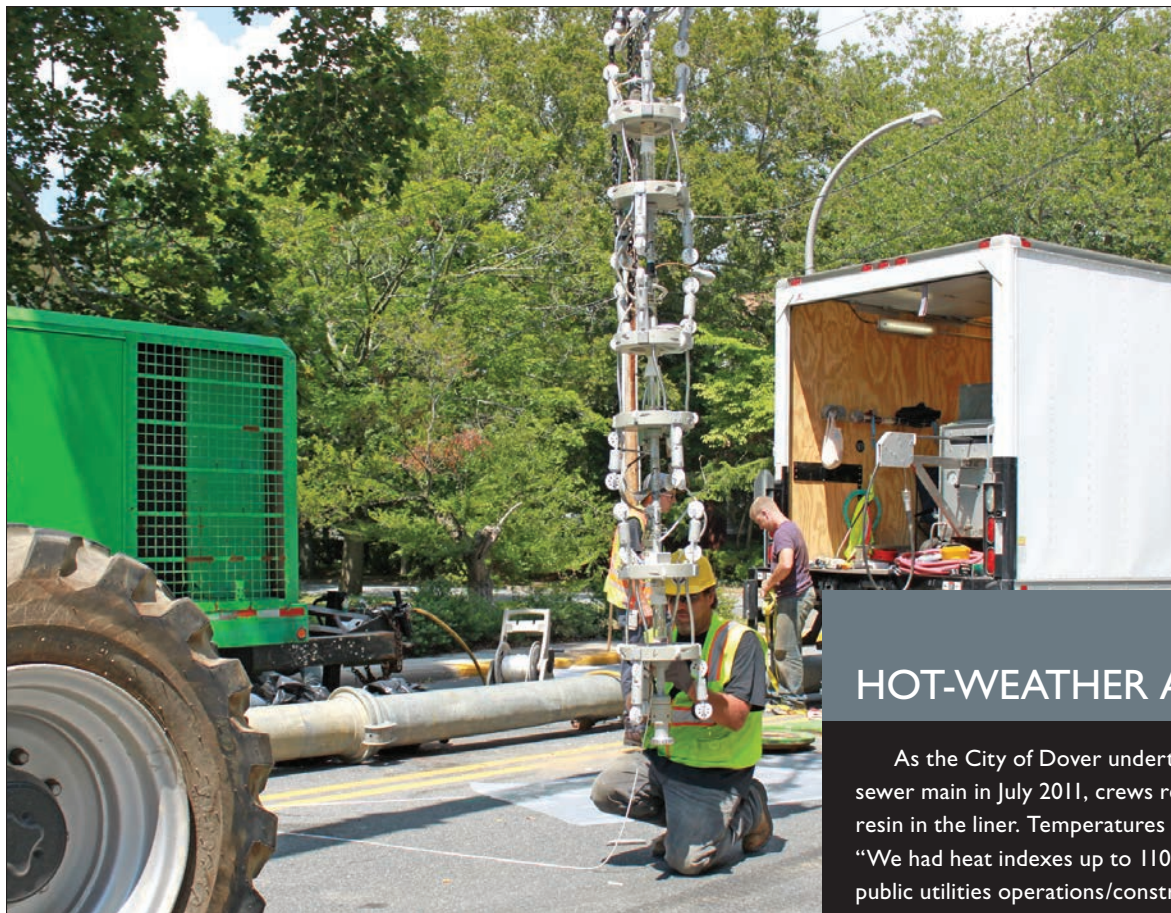
Project superintendent Steve Carbeck checks out the light train to make sure all the parts are ready for another curing session.

The UV light instrument sent through to cure the resin has a built-in camera on the front end — a big advantage because it allows crews to check the inside of the liner before curing it and remedy any flaws they may find.

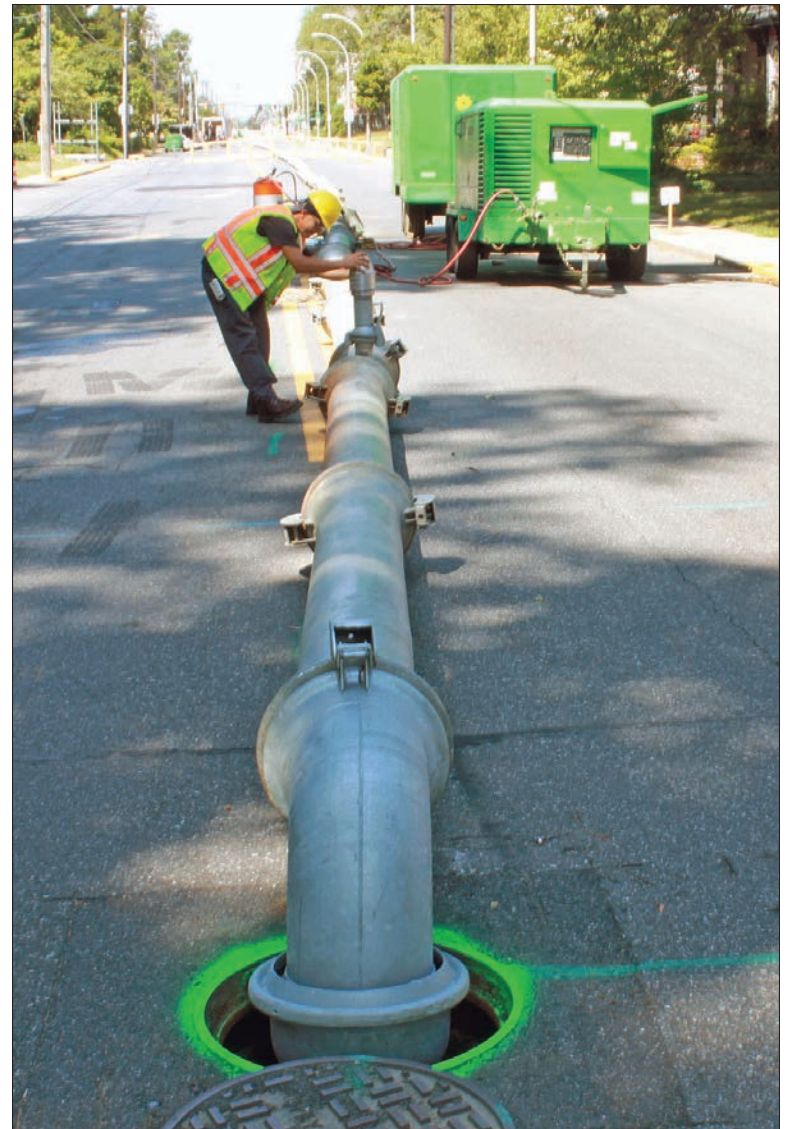
At the end of the mile-long bypass system, a crew member checks the pressure and releases a small amount of air so that the bypass system flows with ease.

interceptor that at the same time receives flow from the local flow basin. The pump station had ample power to drive flow through the bypass, a 12-inch pipeline that ran along the top of the street, for the first half of the project, says Tingberg. When the bypass was set up for the second half, additional pumps were used. At two cross streets that had to remain open during the work, ramps were constructed to carry traffic right over the bypass pipeline.
