► ECO FRIENDLY LARGE BORE CIPP LEVEE REHABILITATION

CIPP Structural Repair of 108" Levee Equalization Culvert System

Lake Okeechobee, FL

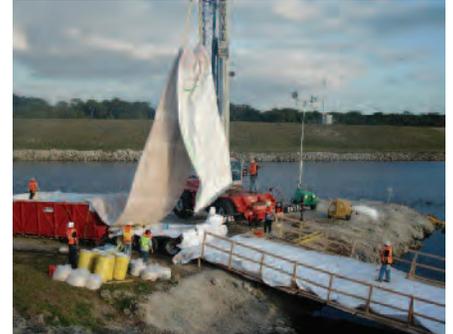
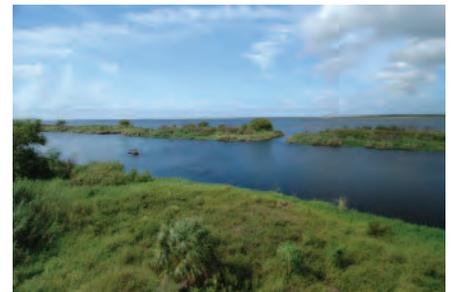
The Army Corps of Engineers contracted with Lanzo Trenchless Technologies for the structural renovation of a twin barrel 108" levee equalization culvert system. A certified industrial dive team was used to carefully inspect and survey the lines prior to the rehabilitation. Utilizing a barge at the mouth of each culvert, Lanzo Trenchless Technologies successfully installed two CIPP liners into the remote pipelines. Each liner weighed over 40,000 pounds. Sluice gate repair and replacements were also part of the project. The location and sheer size of this large bore CIPP installation called for extreme safety precautions to protect our structural rehabilitation team, the environment, and the Seminole community whose lands abutt this critical irrigation lifeline.
