San Diego, California
April 16-19, 2007

Large Bore Rectangular Box Culvert and Non Circular Rehabilitation with CIPP

Fred Tingberg Jr.

Lanzo Lining Services, Deerfield Beach, FL / Roseville, MI

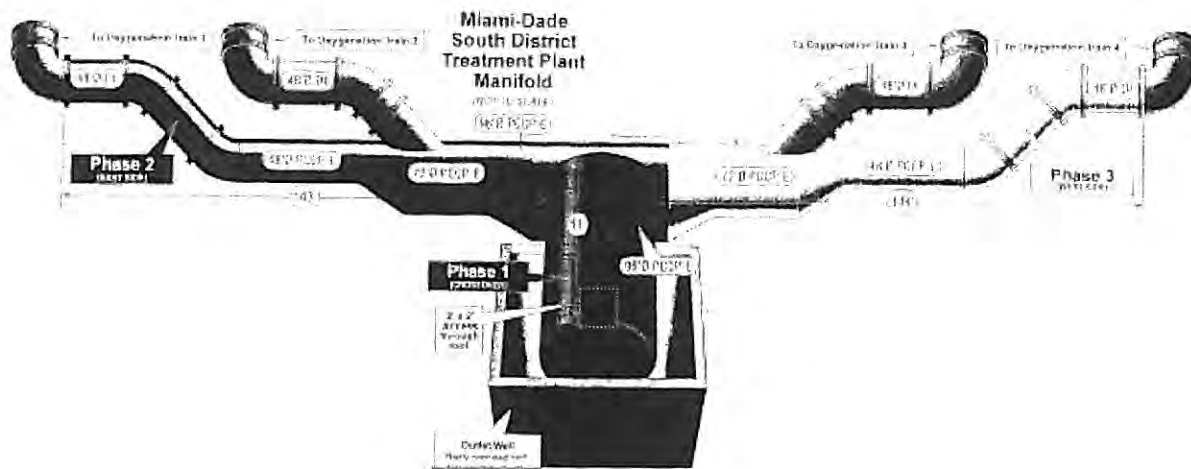
Figure 1 Transitional 96"x72"x48" Cured in Place Rehab favoring methods listed in ASTM F 1743

The ASTM F 1743 installation method allowed for the liner to be winched into place while a careful comparison could be made, in the pipe, between the position of the different material stages and the pipeline anomalies themselves. Once the tube was properly positioned; the inversion of a calibration hose ensued and a precise rehabilitation product was assured.
