► HDPE SLIPLINING FORCE MAIN

72" Sewage Force Main Sliplining Rehabilitation
(Cuban American Association of Civil Engineers Project
of the Year)

Miami Gardens, FL

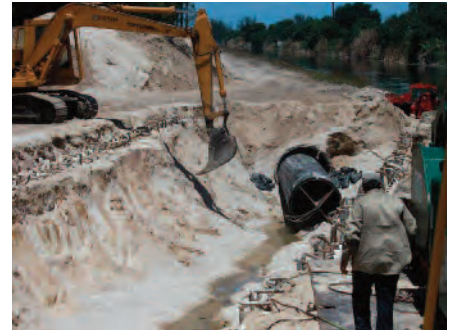
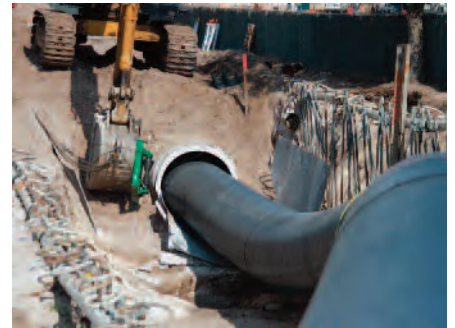
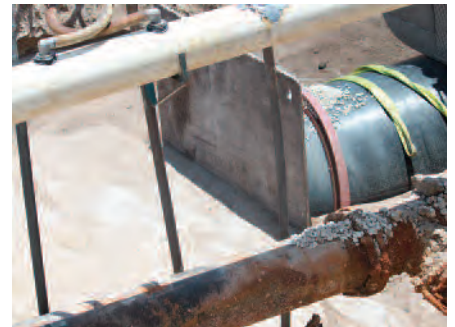
Lanzo Trenchless Technologies was hired to structurally rehabilitate the pipeline. The timing was considered critical. The slipline method of repair required Lanzo to insert 1 1/2 miles of smaller diameter HDPE structural liner into the existing damaged pipeline. Lanzo fused the sectioned HDPE tube into 2000 linear foot strings and pulled each into the concrete pipe. A sliplining project requiring this diameter and length of fused HDPE had never been attempted anywhere in the world. The project was made more difficult because all construction had to be completed within the narrow project window of 90 days. The successful rehabilitation of the "high risk failure" pipe was unique in its construction method, limited by its available schedule and challenging in every phase. To date this remains the largest singular use of HDPE slipline technology in the world.
